# Manhole Inspection Summary

Manhole # S17K\_\_021MH

Insp Date: **4/10/08 10:30 AM**

**Location** Address: **121 warwick st**

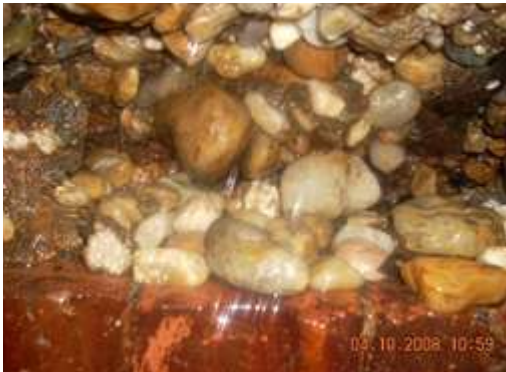
Defect 2

Condition: ☐ Sound ☐ Cracked ☐ Root Intrusion ☒ Loose Brick ☒ Deteriorated

deteriorated barrel wall

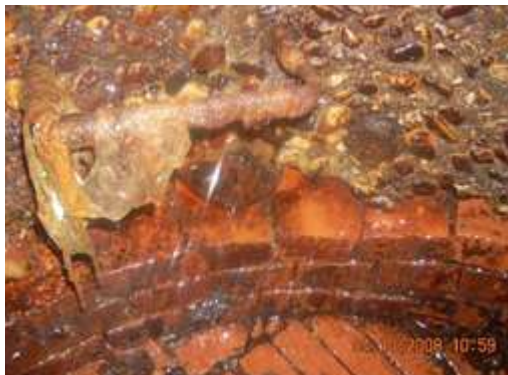
Defect 1

Infiltration: ☐ None ☒ Joint ☒ Cracks ☐ Mortar ☐ Roots ☒ Wall

infiltration @ barrel/bench joint

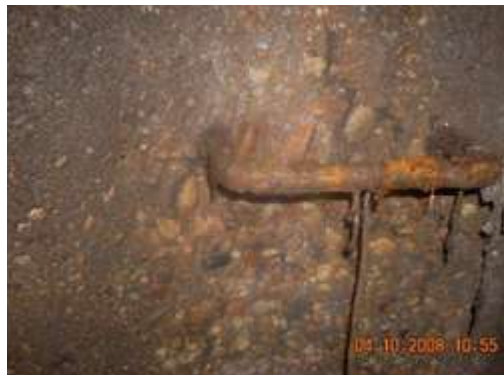
Defect 5

**Steps** Count: **16** Missing: **0** ☒ Corroded

corroded step

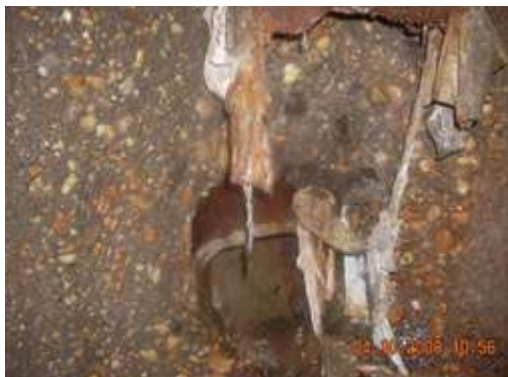
Defect 4

**Surcharge** ☒ Evidence Of Surcharge Depth: **5** (ft.) ☐ Active Surcharge Present

surcharge evidence

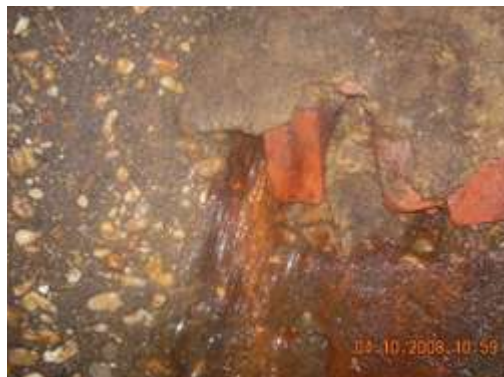
Defect 3

infiltration @ barrel wall; deteriorated concrete with a poor repair, loose bricks

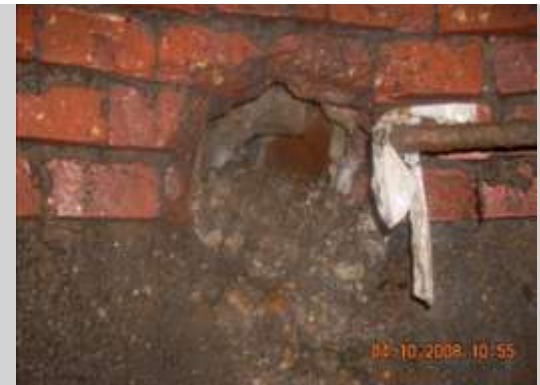
6 O'Clock Inflow

abandoned, closed off

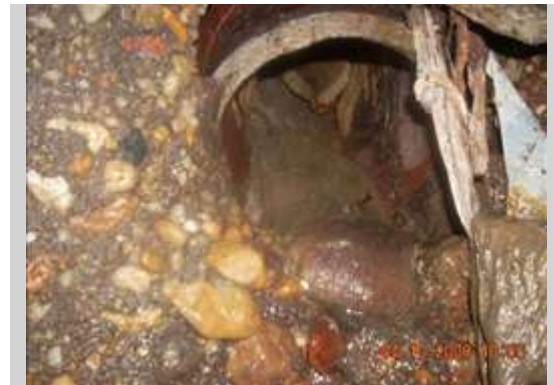
abandoned
